Structural Wood Documentation and Dendrochronology in SE Utah:

**Report on the 2011 field work on Cedar Mesa in Slickhorn Canyon
and in Natural Bridges National Monument**

**2011 Discovery Grant (11-5-BLM/NPS) Final Report
Canyonlands Natural History Association**

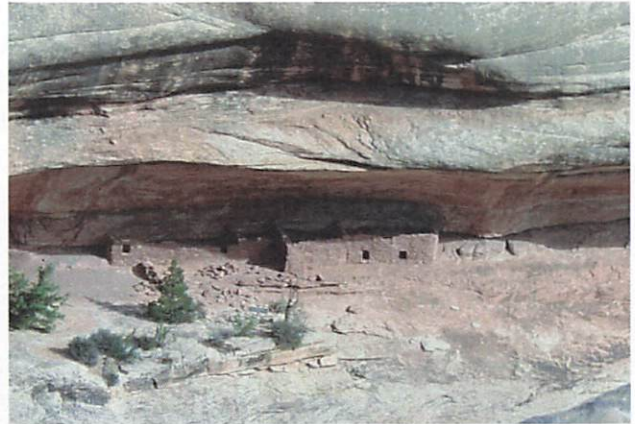
Plate 2. Horse Collar Ruins, NE Unit. Room 2 with 2 doorways. Photo by M. DeSutter June 2006.

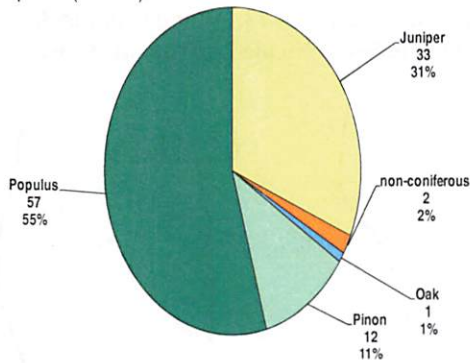
Figure 2. Horse Collar Ruins, structural wood species use. Graph by Eileen Bacha, 2012

Tree-ring Summary: 112 structural wood elements were recorded at the site, with 43 samples taken (38% of the total) and 15 dated (35% dated), all in the first half of the AD 1200s. Those from the Structure 11 kiva contained 70 pieces of structural wood that revealed construction between 1243 and 1247 (9 dates) with a single repair beam or final harvest at AD 1250+B. The Structure 6 kiva, without roofing, revealed construction dates of the ventilator (and probably the kiva) at AD 1226+r and 1227+G (see **Table 3** for the tree-ring date symbols). Species selection was dominated by piñon, juniper, and *Populus* sp., probably cottonwood (**Figure 2**).

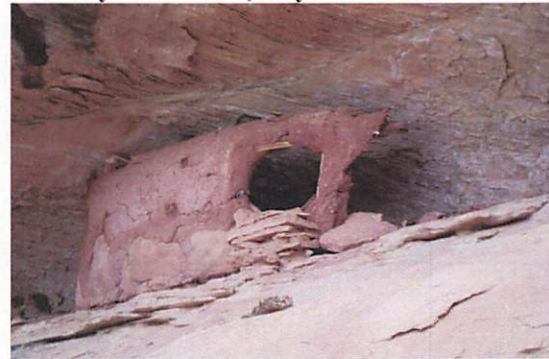
Plate 4. 42SA 29513 granary. Note broken end. Photo by Cliff Evans, July 2011.

There was much structural wood (n=27) associated with this granary, both loose (n=16) and incorporated within the walls, with many pieces scattered inside and around the southeast end where vandals had evidently broken out the wall (**Figure 3**; **Plate 4**). All the loose wood undoubtedly came from use within the wall construction. The majority of the pieces used as intramural pieces were within the adobe walls. These appear to have been gathered as deadwood because of their weathered exterior surfaces despite being protected by the cliff overhang and granary walls. The back wall was formed from the natural rock of the high mushroom-shaped pinnacle.

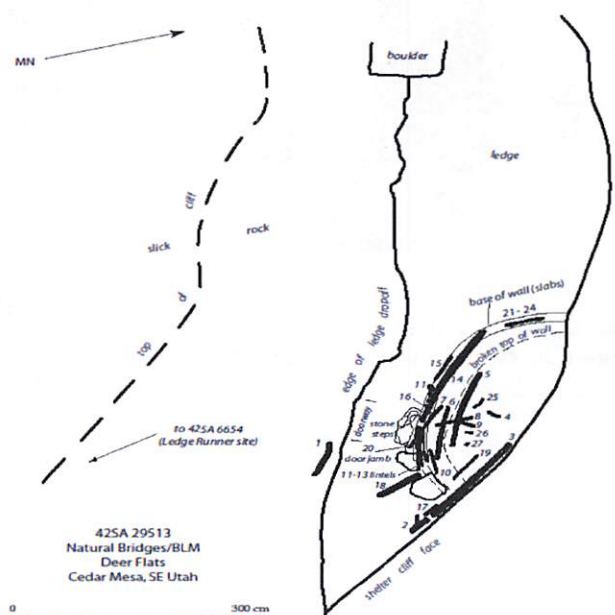
Figure 3. Plan view of 42Sa 29513. Wood is in black. Original by Tom Windes & Nicole LeBrun, July 2011.

The granary interior is 140 by 300 cm with a maximum roof height of 105 cm. The wall construction consists of upright sandstone slabs along its base with mortared unshaped stones for its upper walls (12–15 cm thick), which forms a C-shaped wall. The door faces south (190° true) and is of horse-collar shape, 48 x 48 cm across the opening, and approximately 35 cm above the natural ledge, which is taken up by stone slab steps. The door exhibits small rods for an east door jamb and three lintels/horizontal intramurals.

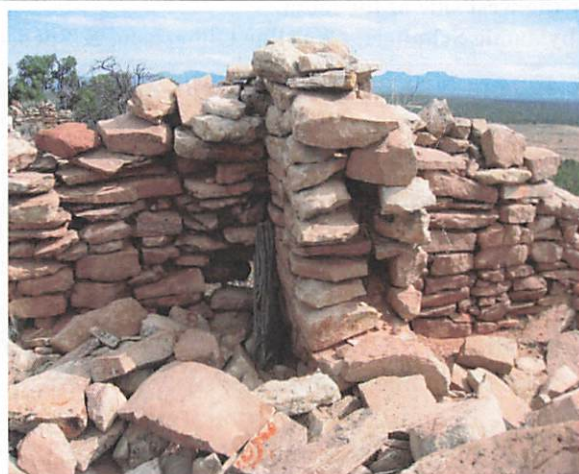
Plate 5. The Fortress on Shieks Mesa. Bear Ears in far background. Note viga fragment FS 21 in Room 2 corner. Photo by Criss Swaim in July 2011.

42SA 3680. Shiek's & Coyote flats, Fortified Mesa, Cedar Mesa. The Fortress is located on a small mesa overlooking Shieks and Coyote flats and is accessible off BLM dirt road 250 from paved State Highway 261, south of Todie Canyon and the BLM Ranger Station. Bill Lipe and RG Matson, who have worked in the area since the 1960s, were particularly interested in the dating of this site because of its potential for being one of the latest occupied. From the top it provides a wide-ranging 360° view of Cedar Mesa and beyond from the top and may have served as an important center for the local inhabitants. Navajo Mountain is easily visible far to the southwest and the nearby Bears Ears are prominent to the north (**Plate 5**).

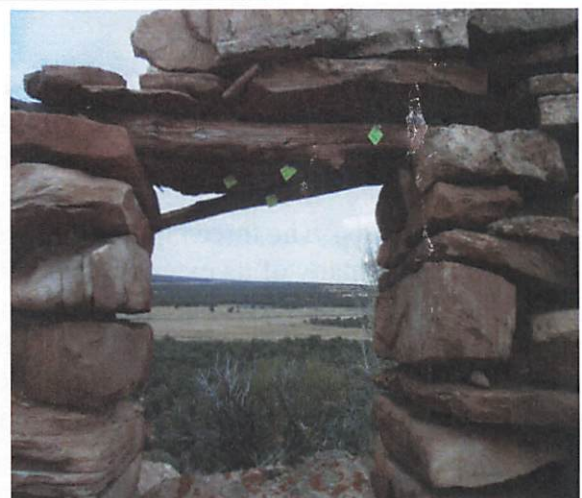
Plate 6. Doorway in the east wall of Room 1. Closest door lintel (green tags) is FS 1. Looking east. Photo by Criss Swaim in July 2011.

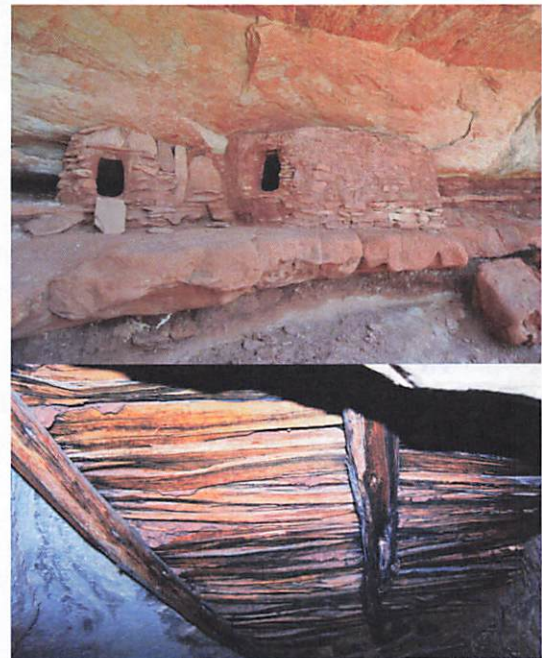
Plate 8. Upper: Storage Rooms 5 (right) & 6. Lower: inside roofing for Room 5. Photos by Kay Barnett, 23 July 2012.

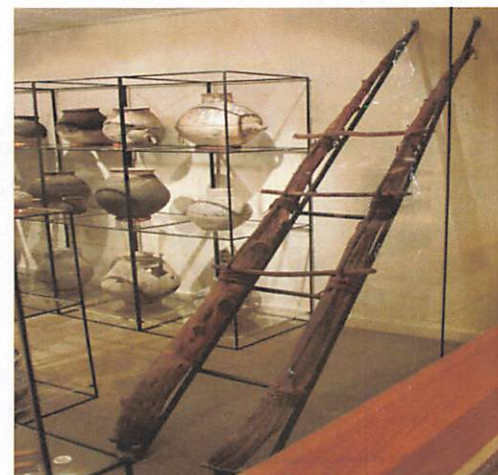
Plate 9. The ladder pulled from Perfect Kiva, now in Edge of the Cedars Museum, Blanding. Photo by T.Windes Feb 2011.

When Vaughn Hadenfeldt visited the site in the 1970s, there was no circle of rock outlining the kiva perimeter on the surface and the original kiva ladder was still in place. This ladder (**Plate 9**) was later removed by the BLM to prevent its loss from theft, and it is curated in the Edge of the Cedars Museum in Blanding, Utah, with a wobbly replacement taking its place. The stone outline of the kiva may also have been placed at the same time. The ladder was sampled as FS 230–236 and measured by the author and Cliff Evans in 2012.

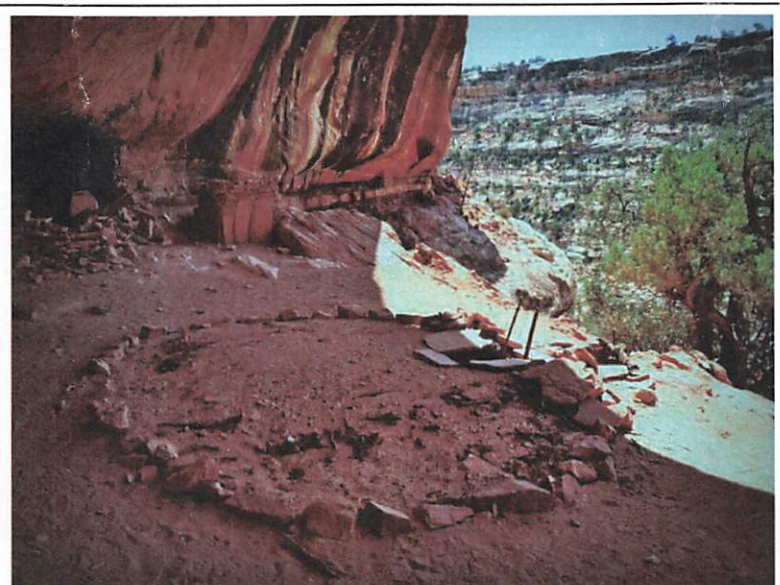
Plate 10. Looking north across the kiva to Rooms 1-4. Note heavy sooting on ceiling of Room 1 at far left. Photo by Blayne Brown, Jul 2011.

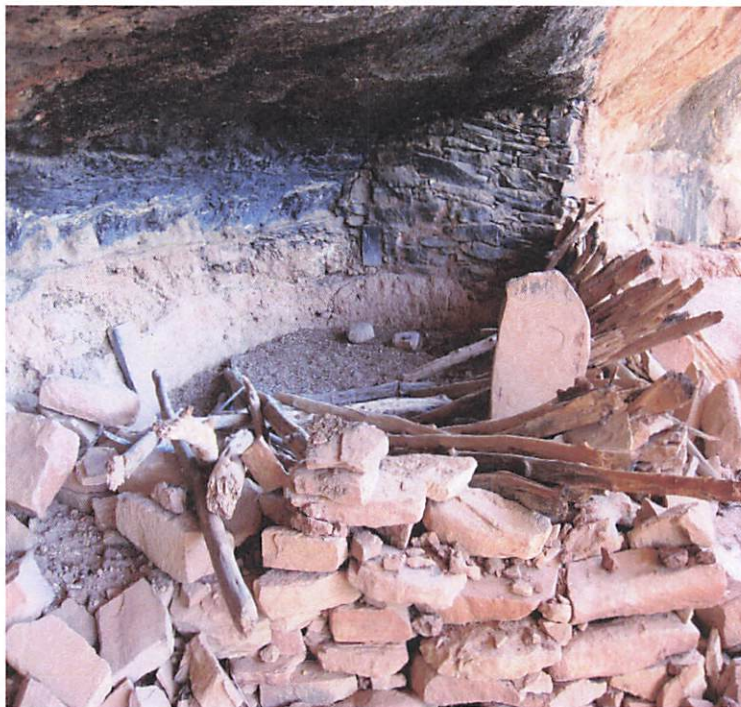
Plate 11. Habitation Room 1. Note collapsed wall poles & vertical door entry slab. Looking north at the sooted south masonry wall of Room 3. Photo by Criss Swaim, July 2011.

through the jacal wall. Part of a slab-lined firepit was evident near the room center. We sampled 54 of these posts and other structural elements but only seven dated (**Table 8**), with the latest at AD 1229 vv, but it is a cutting or near-cutting date based on field observation. Sixteen corn cobs were observed in Room 1 although there are probably more under the fallen jacal wall remains.

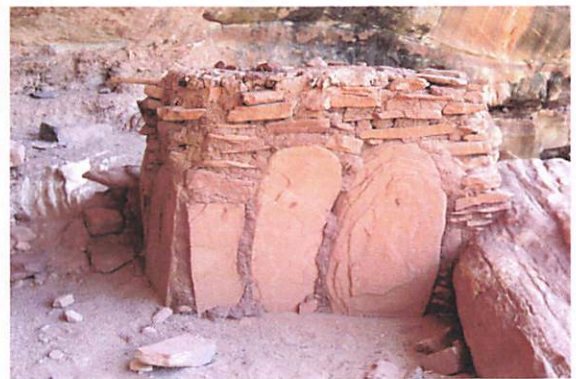
Plate 12. Storage Room 2, south side. Photo by Criss Swaim, July 2011.

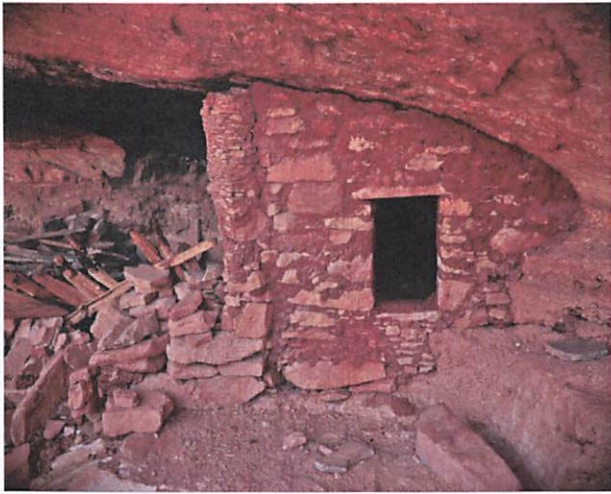
Plate 13. Room 3 at Perfect Kiva, with Room 1's collapsed wall poles on the left. Photo by Blayne Brown, July 2011.

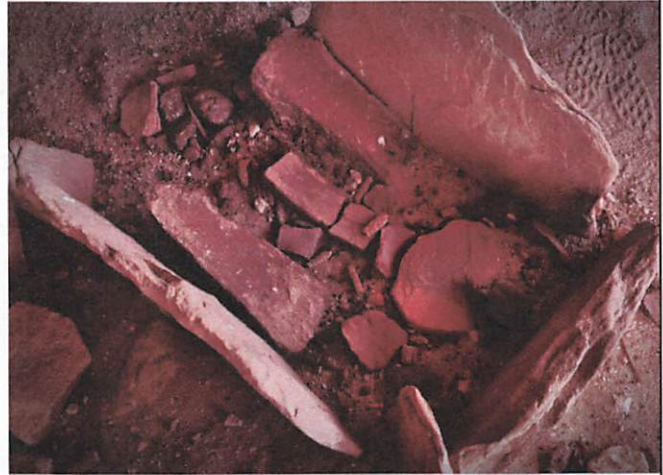
Plate 14. North Mealing Bin at Perfect Kiva; note adobe metate rest fragments in bottom. Photo by Blayne Brown, July 2011

Room 5. Just to the west of 2.3 m from Room 1 along the shelter wall is an outline up and across and back down that marks a former structure that reached the rock ceiling. From the wall outlines, this room must have been about 3 m across and built out from the shelter wall about 2 m. Under the ghost line is a pair of contiguous **mealing bins** (Plate 14), placed so that the grinder could brace their (her) feet against the shelter wall about 1 m away. The metates that were once used in the slab-lined bins are missing, although one slab metate (22 cm wide, 22 cm+ long, and 5 cm thick) is presently leaning against the Room 1 south wall exterior next to Room 3. Broken adobe metate rests are present in the bins along with 23 corn cobs.

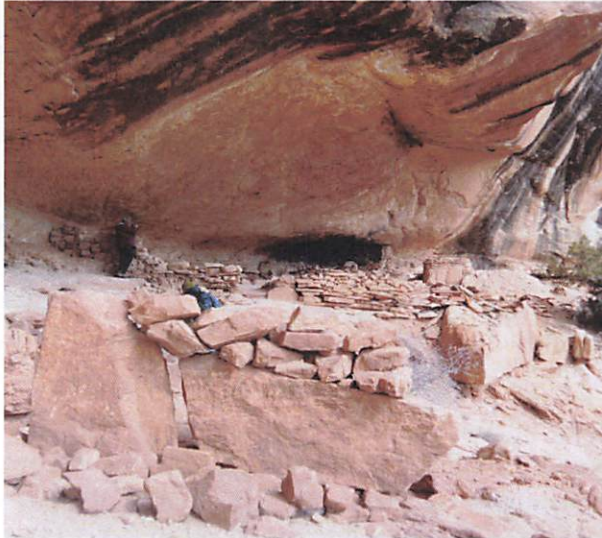
Plate 15. Part of the outer area wall at Perfect Kiva. Main retaining wall is just behind it. Sooted area is Room 1. Looking north. Photo by Nicole LeBrun.

Finally, there is yet another low, short **masonry wall** that crosses the bench to the southwest of the main site that provides the outermost entry into the shelter site (**Plate 15**). It is 16.8 m west (230°) of the main retaining wall's stepped-up entry and has a maximum height of 75 cm, is 30 cm wide, and 170 cm long. There was perhaps another 75 cm of wall, now missing, that would have appended the wall to the cliff face.

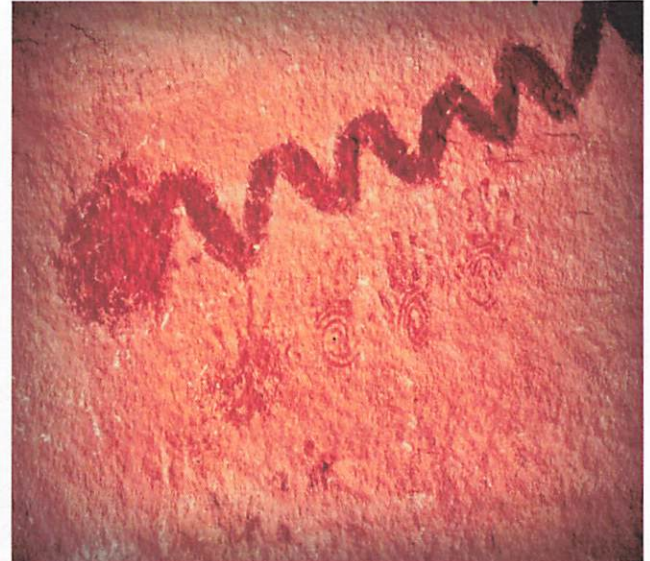
Plate 16. Pictographs in the Perfect Kiva rock shelter. Photo by Blayne Brown, July 2011.

Rock Art. Greater than 100 painted, scratched, incised pictographs and petroglyphs are evident on the rock shelter walls (**Plate 16**), on the kiva's plastered walls, and in a separate cliff face, a small shallow shelter around to the northeast about 70–80 m from the kiva (see the IMACS form for details). A low rock wall about 5 m long crosses the east side of that shelter, which has two panels of pictographs in it.

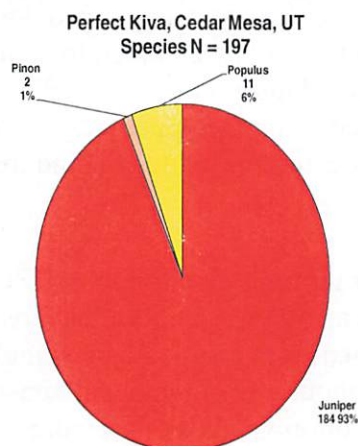
Figure 15. Perfect Kiva site structural wood beam end ax-cuts. Graph by Eileen Bacha, 2014.

The single dated specimen (FS 222) from the shelter inner retaining wall was clearly deadwood based on field observation (it has uncut limbs), which dated at AD 1127+vv (a near-cutting date) but it is not relevant to the interpretation of the primary harvesting and construction at the site. Juniper was the overwhelming choice for use at the site (184 of 197 elements with species identified; 93%), with scant use of *Populus* sp. (11; 6%), and piñon (2; 1%), while five more oak and willow elements were used to make the perfect kiva ladder (Figure 14). Few stone-ax cuts were observed among the site's structural elements (Figure 15), as most elements were either broken at the ends (in Room 1) or hidden from view (in the kiva).

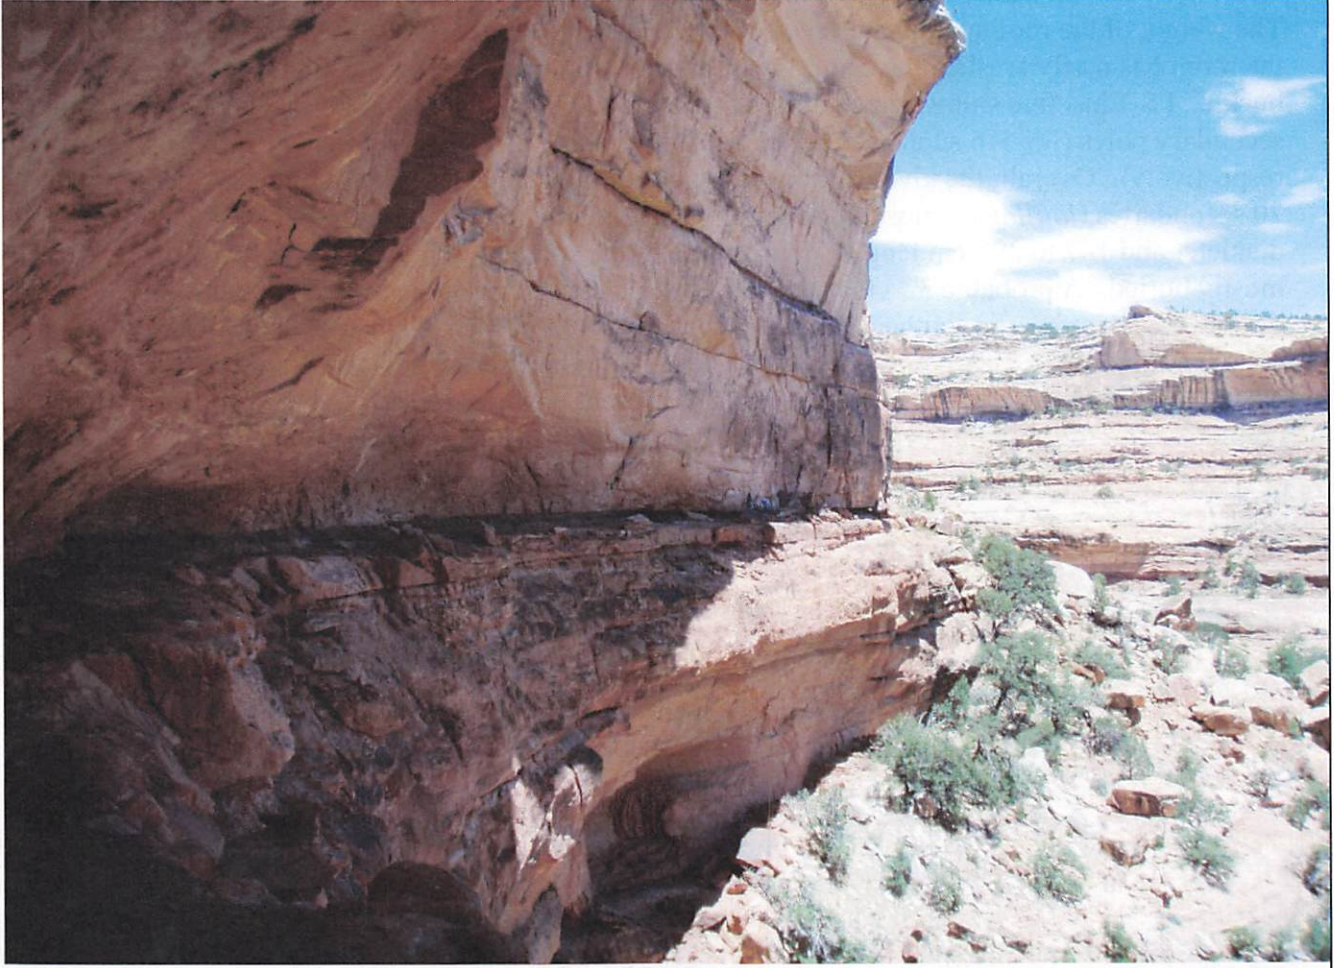
Plate 17. Overview of the Blue Man/Square Kiva site, 42SA 29514, looking east. View of the northeastern end of the Upper ledge and the lower small alcove where room 1 is located. The square kiva and Rooms 1–4 are along the lower cliff face just beyond the alcove by the short trees. Photo by Chris Gilbertson, July 2011.

42SA 29514. The Blue Man/Square Kiva Site. **Location:** Down canyon from Perfect Kiva (42SA 5795) in the canyon bottom of Slickhorn, along the north side, is a huge occupied alcove well-back from the main wash (**Plate 17**). When we visited the site, we plunged down the steep talus directly in front of Perfect Kiva to the canyon bottom below and then took about 25 minutes to walk down canyon to it. This site was not discovered during the 1960–1970s Lipe-Matson surveys because there is little architectural evidence along the upper ledge when seen from below, and the lower part of the site, with much architecture, is hidden behind trees and the talus slope.

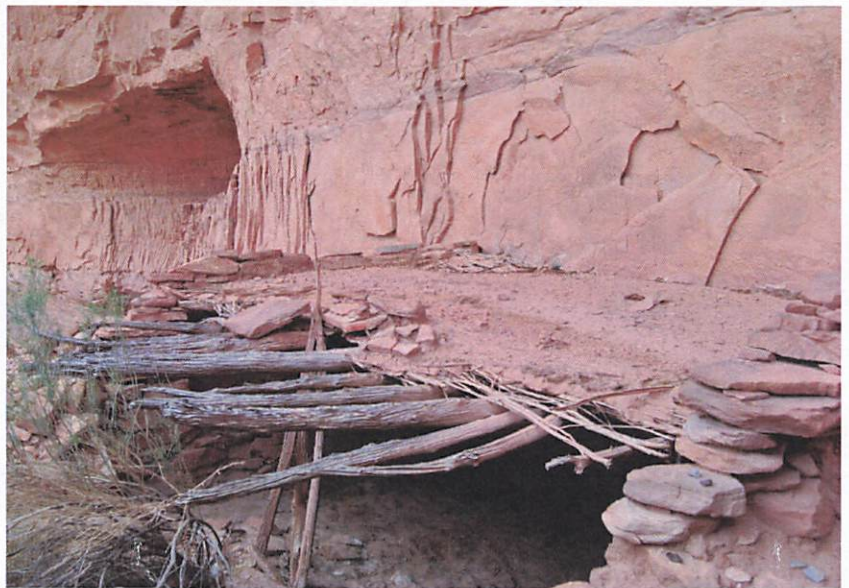
Plate 18. Square Kiva, looking NW across to the small alcove where Room 1 is located. Photo by Kay Barnett, 20 July 2012.

Along the Lower Cliff Face. The Kiva (Figure 18; Plate 18), a square, 360 by 360 cm structure (13.0 m²), is built along its northwestern bedrock wall against the cliff face and has intact northeastern and southwestern masonry walls with three pilasters along each (Table 9). The weight of the roof and the massive cottonwood roof primary (FS 1) spanning the center of the room has partly crushed the central west pilaster (#2), causing the wall and pilaster to partly buckle. FS 1 has five shims spread across the top to slightly elevate and level several of the roof secondary poles (FS 4–6 supported by shims 36–37; and FS15–17 supported by shims FS 35–33, respectively). Overall, the kiva exhibits two vigas (439 and 445+ cm long) in place overlain with 20 secondaries (*latillas*), almost all of cottonwood and ranging in size from 5.3 to 11 cm in diameter and 147 to 398 cm length. The outline of the southeastern wall is poorly defined and mostly buried. A probable 3rd viga spanned the kiva along the southeast wall but has disappeared, leaving the southeastern roof secondary ends suspended in space (Plate 18). A cottonwood viga (FS 38), 497 cm long and 15.5 cm in diameter, in adjacent Room 3 to the northeast might now hold that missing viga. Its present position appears to be positioned correctly for a roofing viga in Room 3 but it is probably set much too low for that roof.

The roof closing material is tied to the latillas underneath, with a total of 50 tie sets, although much of the closing material is missing from the southern third of the structure. Most of the NNW/SSE running latillas extend across the roof. Three small, short poles (128, 142, and 164+ cm long; FS 23–25) lean vertically against the central viga (FS 1)(Plate 18), which may have been ladder poles, however, there is no evidence for a roof entry. Entry must have been made from the south side where the greatest deterioration has occurred. The three poles were sampled in 2012 but two were cottonwood and not sent to the lab. The remainder (FS 25) is of juniper and remains unanalyzed. The roof height above the interior sandy fill is 152 cm.

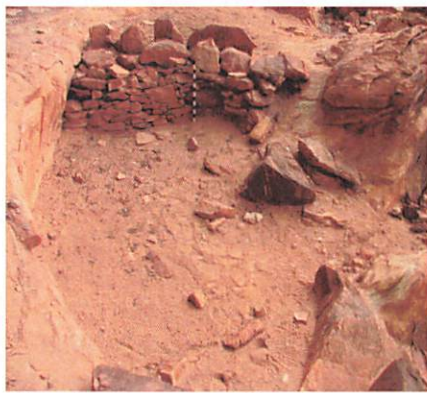
Plate 19. Room 1 at Blue Man. 70cm scale. Photo by Richard Moeller, July 2011.

Room 1 (Figure 17; Plates 19-20), about 244 by 480 cm (ca. 11.7 m²), is built into a natural eroded area that cuts into the stepped bench cliff face directly below a small shallow alcove. It lies separated from the other features along the natural route up to the site from the canyon bottom if one approaches west up the side arroyo that empties the larger cove area. There are only built walls along its northeast side, which consists of an interior, dry-laid masonry wall backed by natural fill and a wall of upright slabs along its surface exterior. There was probably a masonry wall along its southern side, which has collapsed down slope. No roofing is evident for this room and it may never have been roofed. Its size suggests a habitation room but no floor features are evident, although sand fills the room.

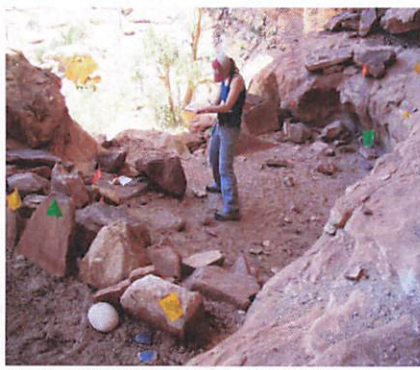
Plate 20. Room 1 at Blue Man looking SW. Claire Jones taking notes. Note artifacts against outer slab wall. Photo by Chris Gilbertson, July 2011.

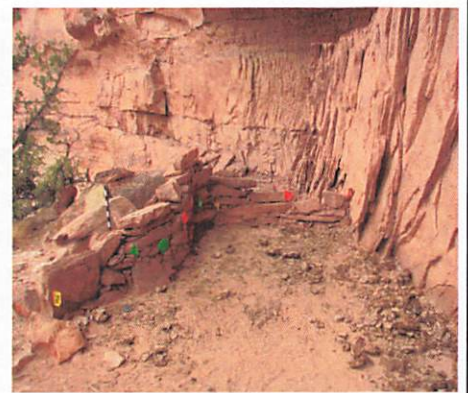
Plate 21. Room 2 looking west towards Room 1 alcove. Photo by Richard Moeller, July 2011.

Room 2 is an irregularly-shaped room (Figure 17; Plate 21), 198–325 by 630± cm NE-SW; 19± m²) built against the cliff face immediate west of the square kiva upslope from Room 1. It incorporates a couple of talus boulders into its stone masonry wall construction. The highest of the room walls (93 cm) is along the southwestern side, but there is considerable wall rubble, boulders, and some refuse just outside the wall exterior covering the trail-access up from Room 1. Along the open southeastern side is a partial row of upright slabs (0-5 cm high) barely visible above the fill and partly curving along the inner masonry wall to the west, which is an odd arrangement if it is the remaining contemporary wall for the room. No masonry wall is left intact along the room’s northeastern side but it is marked by a tumble of masonry-size stones. A cliff face boulder may form part of the room along its southeast side.

No roofing is evident for this room and it may never have been roofed. Its size suggests a habitation room but it is unsooted and no floor features are evident because the room is filled with deep sandy deposits. The presence of dung in the northwestern part of the room indicates some damaging cattle presence at the site.

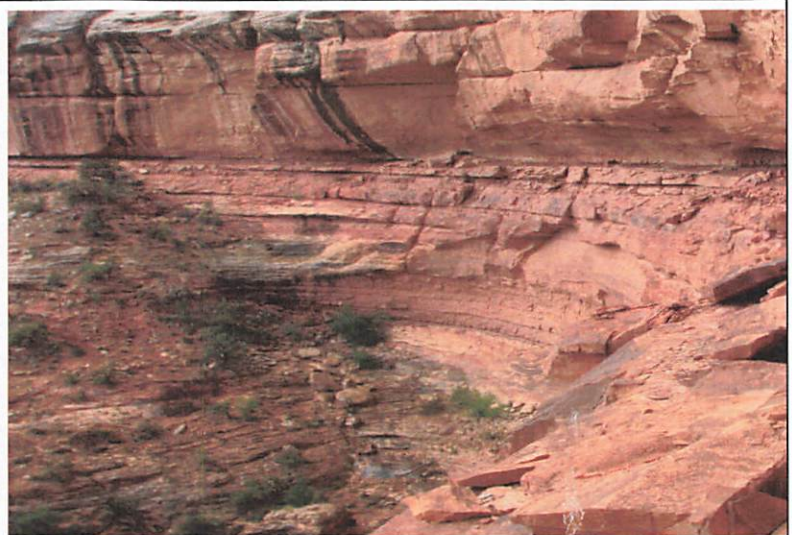
Plate 22. Looking west along the Upper Ledge of 42SA 29514, the Blue Man/Square Kiva site. Photo by Richard Moeller, July 2011.

Along the Upper Ledge (Figures 19–20; Plates 17 and 22)

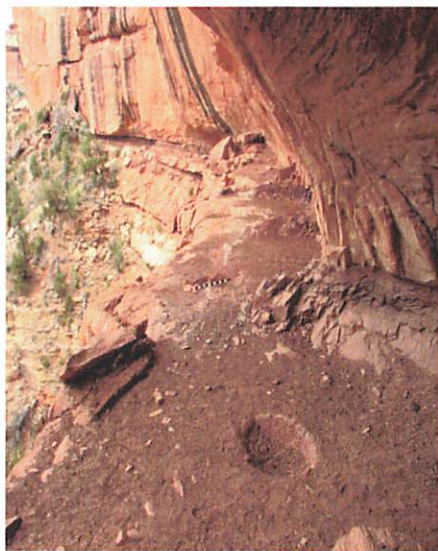
Plate 26. Firepits 2–3 along the middle of the ledge. FP 3 in background with 70cm scale just in front. Photo by Richard Moeller, July 2011.

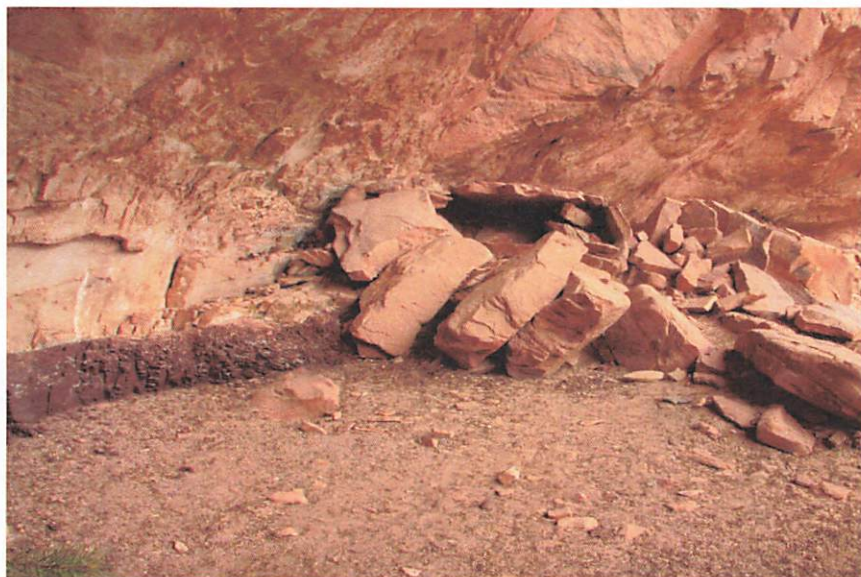
Plate 27. At the southwestern end of the Upper Ledge looking NW is a small sooted room that probably served for storage (Feature 21) (center of photo). The small cist box (Feature 24) mentioned above is located just off the photo to the left. Photo by Richard Moeller, July 2011.

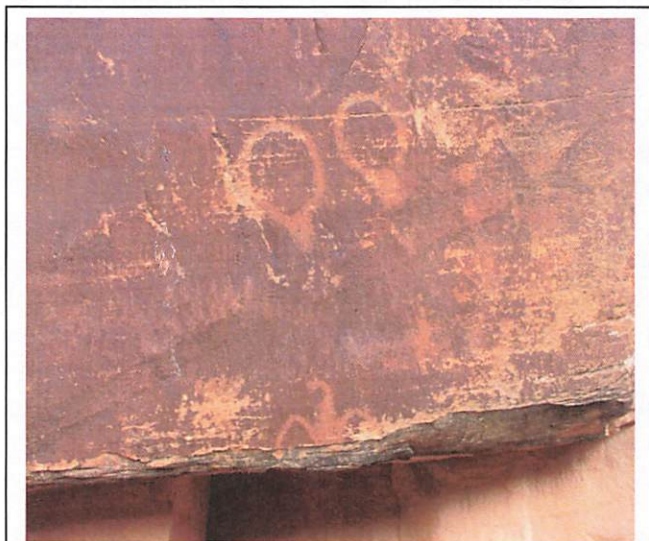
Plate 28. Petroglyphs at the east end of Upper Ledge. Photo by Richard Moeller, July 2011.

Rock Art: At the east end of the upper ledge roughly above Room 4 are the densest rock art panels ([Plate 28](#)), recorded by Sally Cole and her team several years ago and again by Pam and Quent Baker, Leigh Grench, and David Manley during our project. But there are many more, mostly pictographs, along the Upper Ledge cliff face along the southwestern ledge area, including the Blue Man pictograph ([Plate 29](#)). The blue paint was obtained along the ledge deposits that are exposed below the pictograph.

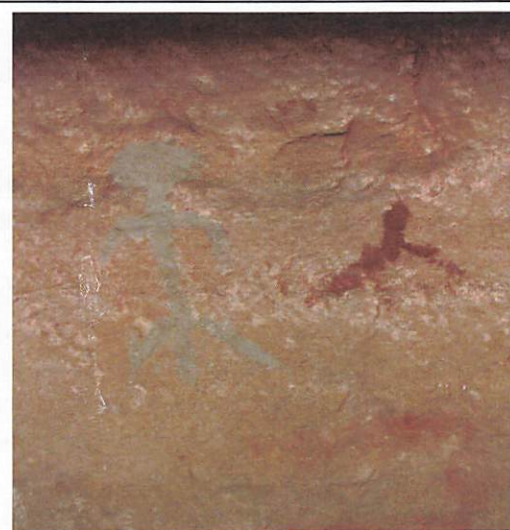
Plate 29. Blue man and other pictographs along the southwestern Upper Ledge. Photo by Richard Moeller, July 2011.

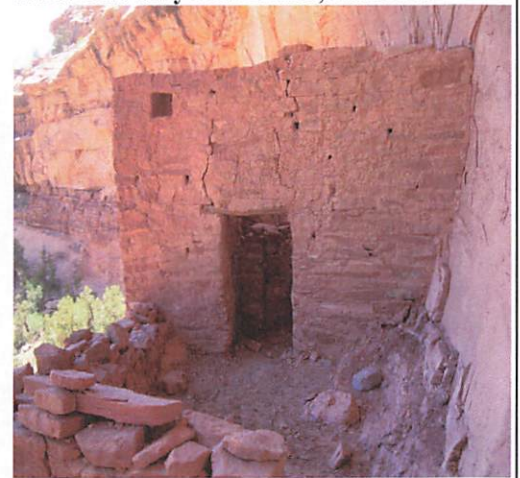
Plate 33. 4 Shield House, looking across Room 3 to the restricted doorway entry into the kiva (Rm 4). Note the many loop holes. Photo by Don Keller, ca. 2011.

Remnants of two *Populus* sp. poles (FS 16–17), which once extended at an angle above and at each side but away from the inner top of the doorway (147–152 cm above the floor), are of unknown function. Two rectangular masonry niches are placed opposite one another in the gap left in the middle wall to help provide access up and out of the doorway tunnel end. This is a very unusual entry that can be easily defended. The entry from Room 3 is overlooked by nine small loopholes that penetrate the outermost two-story wall and two others in the 3rd, innermost wall, that blocks off the doorway tunnel at its west end, forcing an upward entry. The exterior masonry of the doorway reveals two tiny holes on either side that may have held willow branch loops in which to fasten a large door cover.

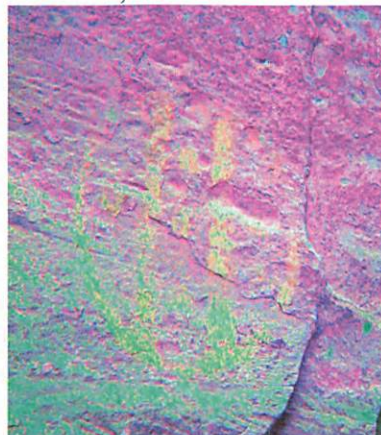
Plate 41. Shield 2 pictograph 96 cm across & above ledge 250cm in Room 5. False color photo by Ben Bellorado, 5 June 2012.

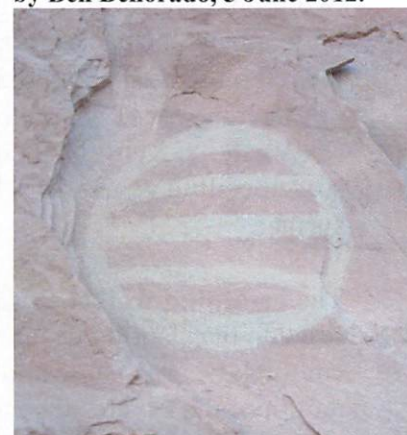
Plate 42. Shield 3 pictograph 102cm across & above ledge 240cm, just west of Room 6. Photo by Ben Bellorado, 5 June 2012.

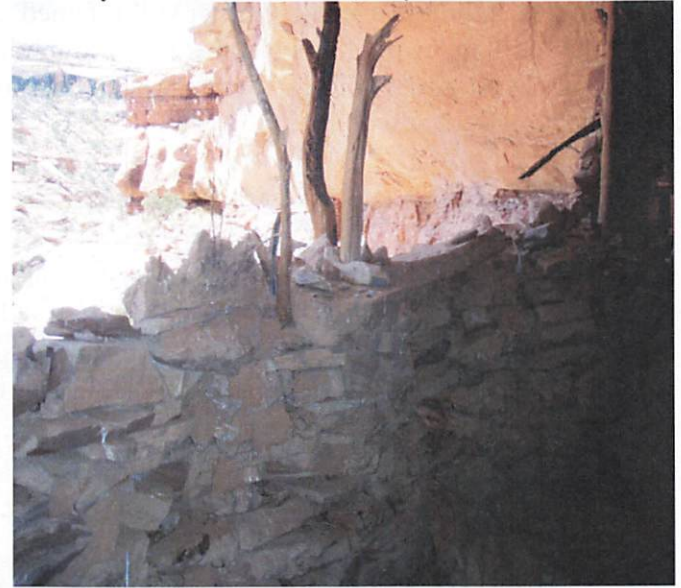
Figure 29. The 4 Shield House, East Cavate retaining wall, looking north at the outside elevation. The wood is in black. Original map by Ben Bellorado, 4 June 2012.

The area behind the wall is filled with dark sand and refuse deposits that helped level the use area. The fill was scattered with corn cobs,

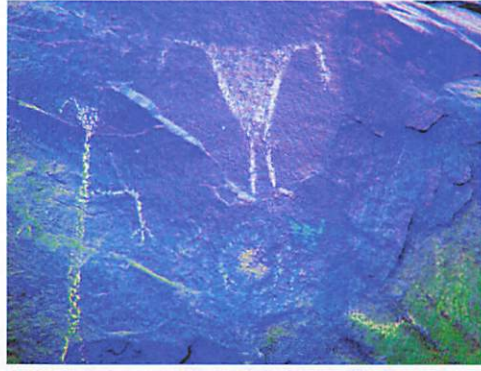
Plate 46. BMIII images above storage Room 10. False color photo by Ben Bellorado, June 2012.

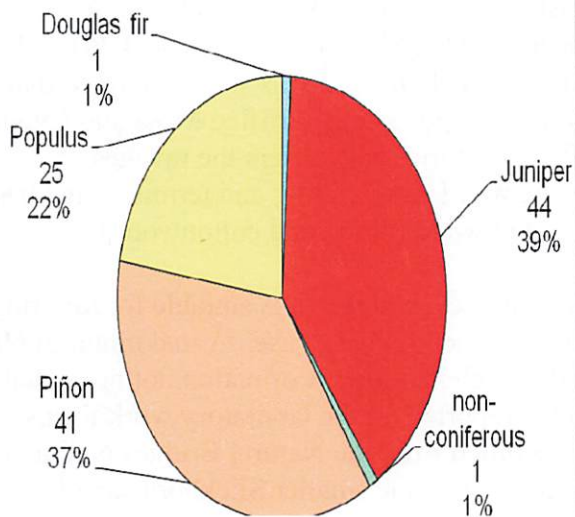
Figure 32. Stone-ax-cut beam-end types of structural wood at 4 Shield House. Graph by Eileen Bacha, 2014.
